E906/SeaQuest Report

Michelle M. Medeiros
for the SeaQuest Collaboration

Jul. 11, 2016.

- Two weeks report: Jun. 27th - Jul. 11th.

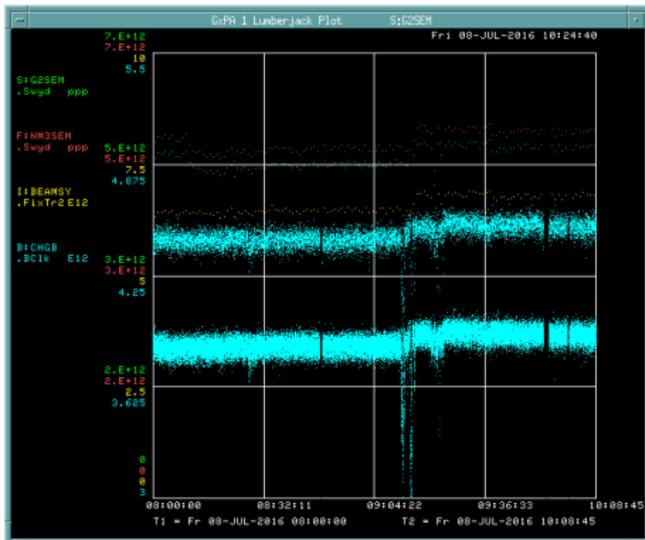
- D2U chambers started giving short HV alarms.
 - Had to lower the voltage to stop the alarms.
 - Called MCR to see if there was something different with the beam.
 - At first, nothing seemed different...
-
- Later, Adam Watts realized there was a slight increase in beam intensity in the Switchyard beam due to efficiency improvement after some booster injection RF capture tuning.
 - The time matches with the start of the trips. There is a correlation but we're not sure if it is indeed the cause.
