Operational Readiness Clearance

SeaQuest E906

AUTHORIZATION TO RESUME THE REMOTE OPERATION OF E906 (SeaQuest)

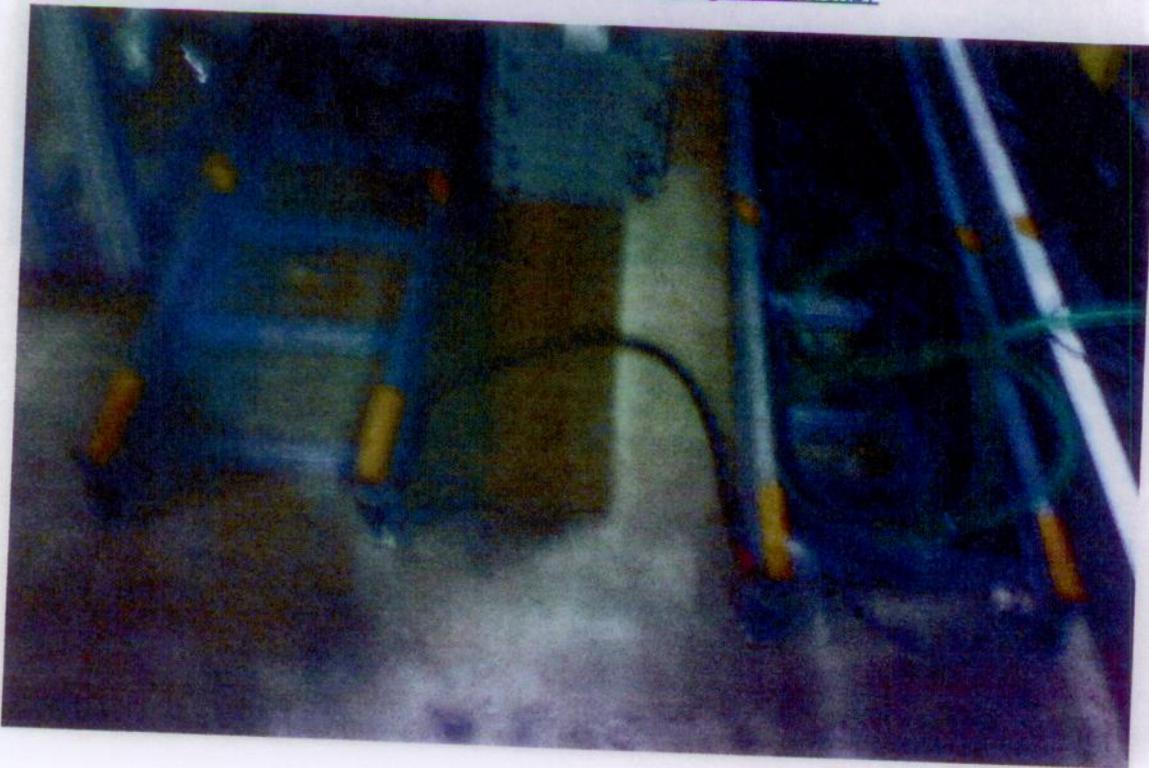
- 2) The floor cable trays used to route and channel the HV and signal RG58 cables, laying under the detector frames, are not connected to building ground. While bonding these cable trays to building ground is not required in this particular situation, it is good practice to ground all cable trays. Therefore, it is **recommended** that these cable trays be connected to building ground.

Paul,
Bob Barger grounded the Station 4 cable trays on the floor.
He also extended the HV connection cover on the Station 3 minus chamber.
See Pictures.

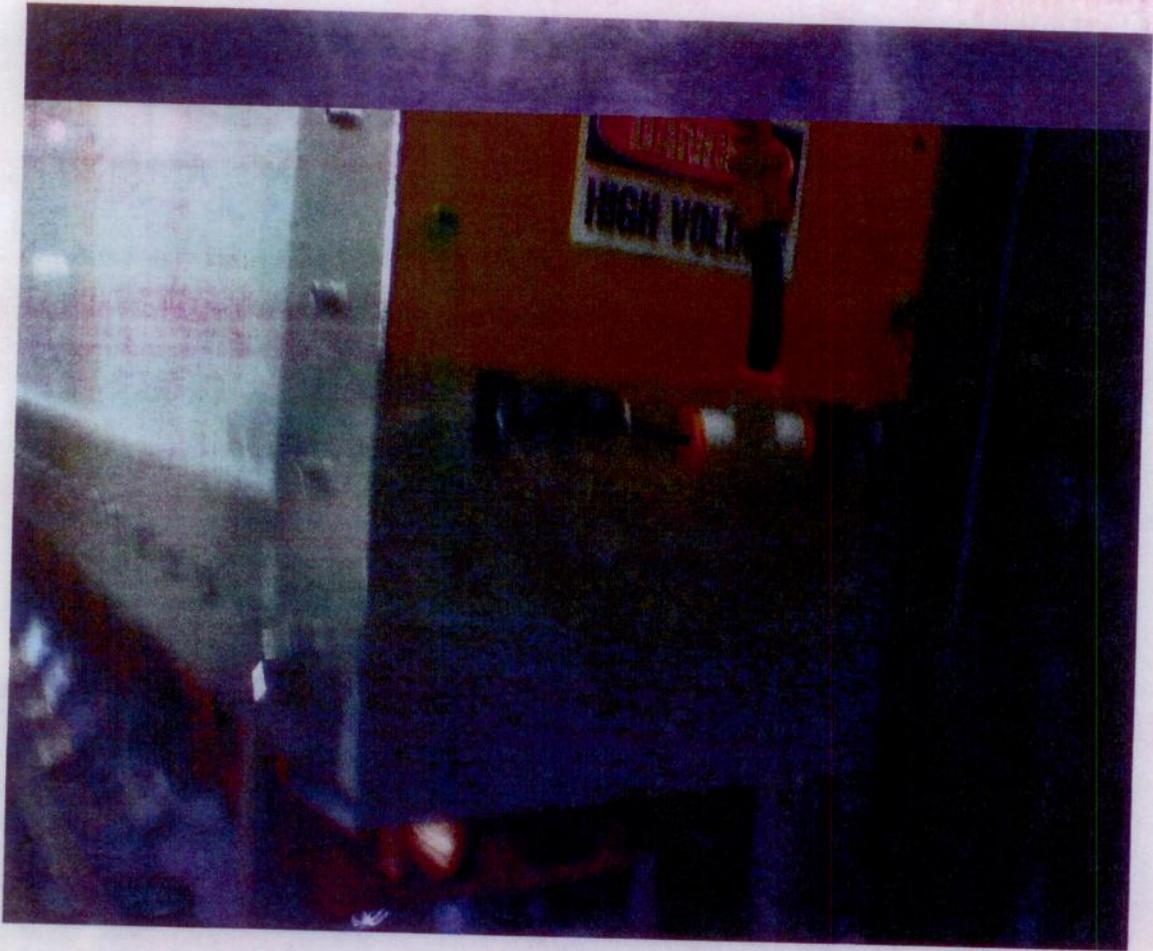
- 3) The cover plate, which was installed as a requirement from the previous review (item 6), still leaves the small HV wires at the bottom of the frame unprotected. These wires are accessible and are exposed to potential damage. Therefore, **require** an additional cover plate, notched out for the gas fittings, to extend the plate's protection to these HV wires at the bottom of the detector frame. Also, require that a HV warning label be placed on this cover plate (Done during the review.)
